**CASE STUDY**

# PROOF OF THE PUDDING

**Histon Preserves (Hain Daniels Group).**

RS Industria alerted Histon's engineers to potential failure of a key asset, averting a costly interruption to production.

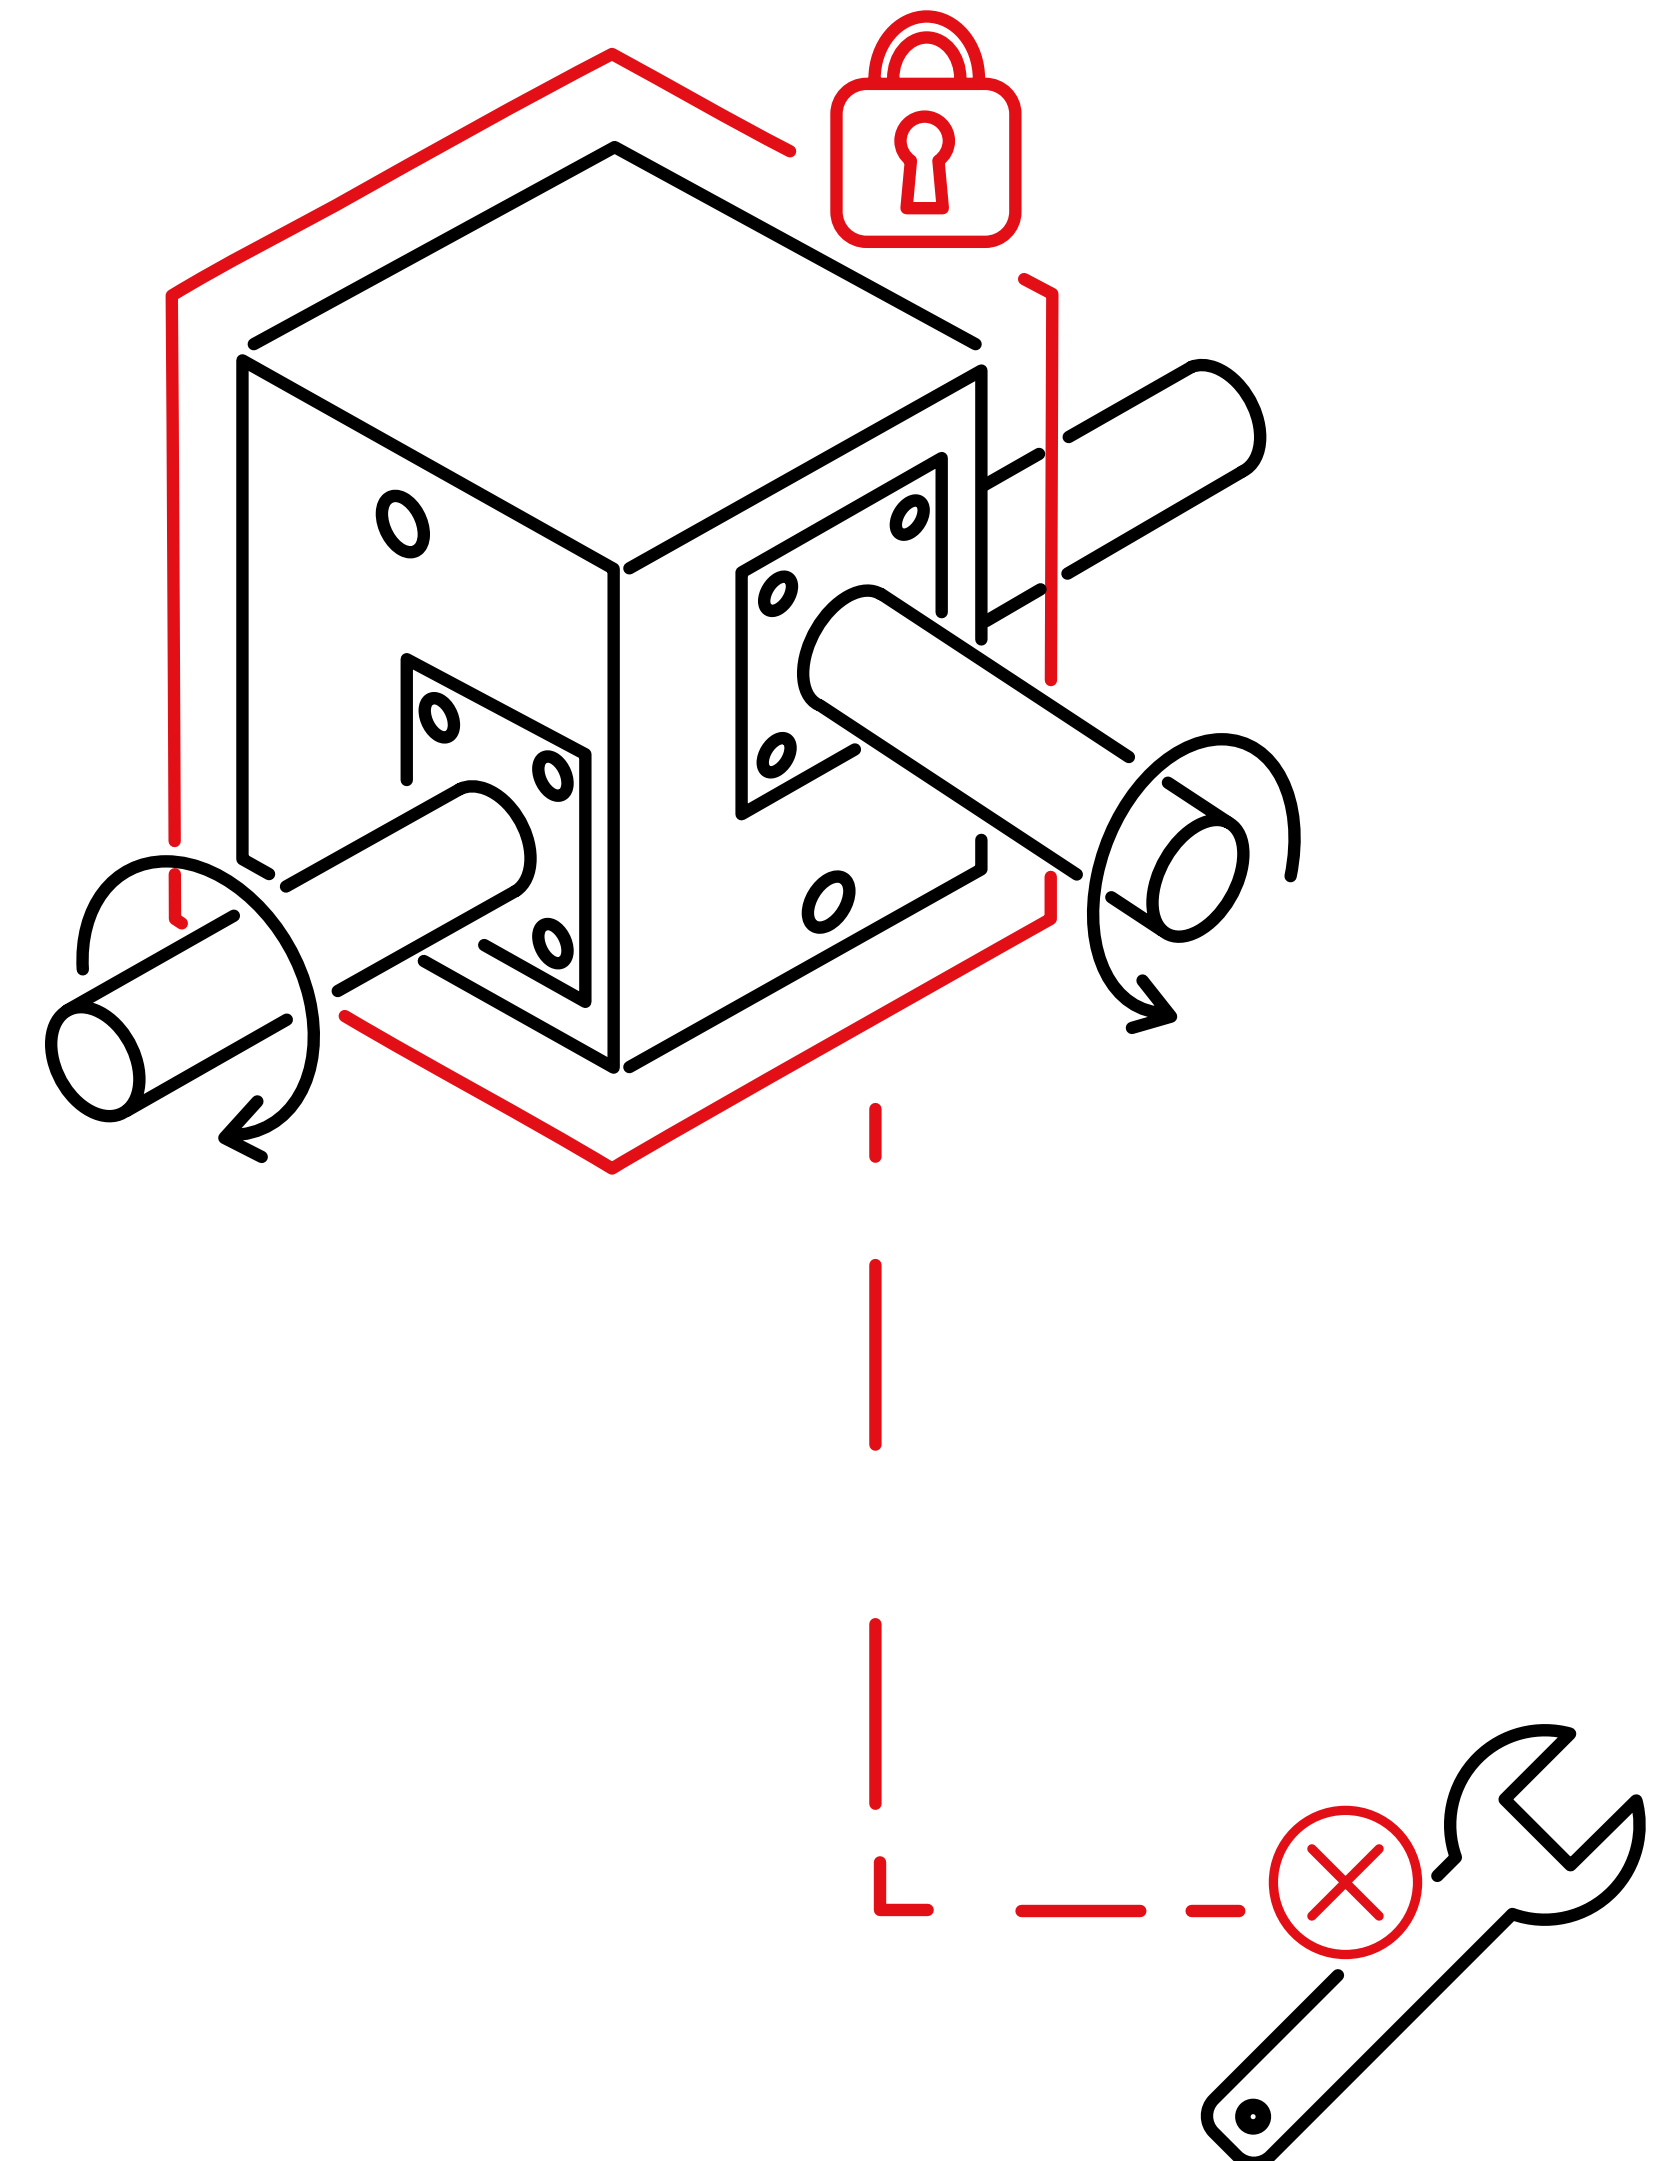
Right-angled power transfer boxes are an essential part of the site's high-speed filling machines. Simple components, which are used extensively by manufacturers as a robust solution for transferring power within a single machine, the transfer box connects the main filler to the blower, ensuring that two key parts of the machine are always synchronised.

The transfer box does however present some maintenance challenges for Histon's engineers, as they are assembled and sealed when manufactured and can't be opened up for routine internal inspections. As the boxes don't generally feature sight glasses, engineers are also unable to view the internal lubricant level.

Transfer boxes are usually located under the filler production line, making external inspection difficult. This has several consequences; if not regularly cleaned, the boxes are usually covered in food debris, which is often corrosive (especially sugary or acidic products), damaging the casing and resulting in lubricant loss.

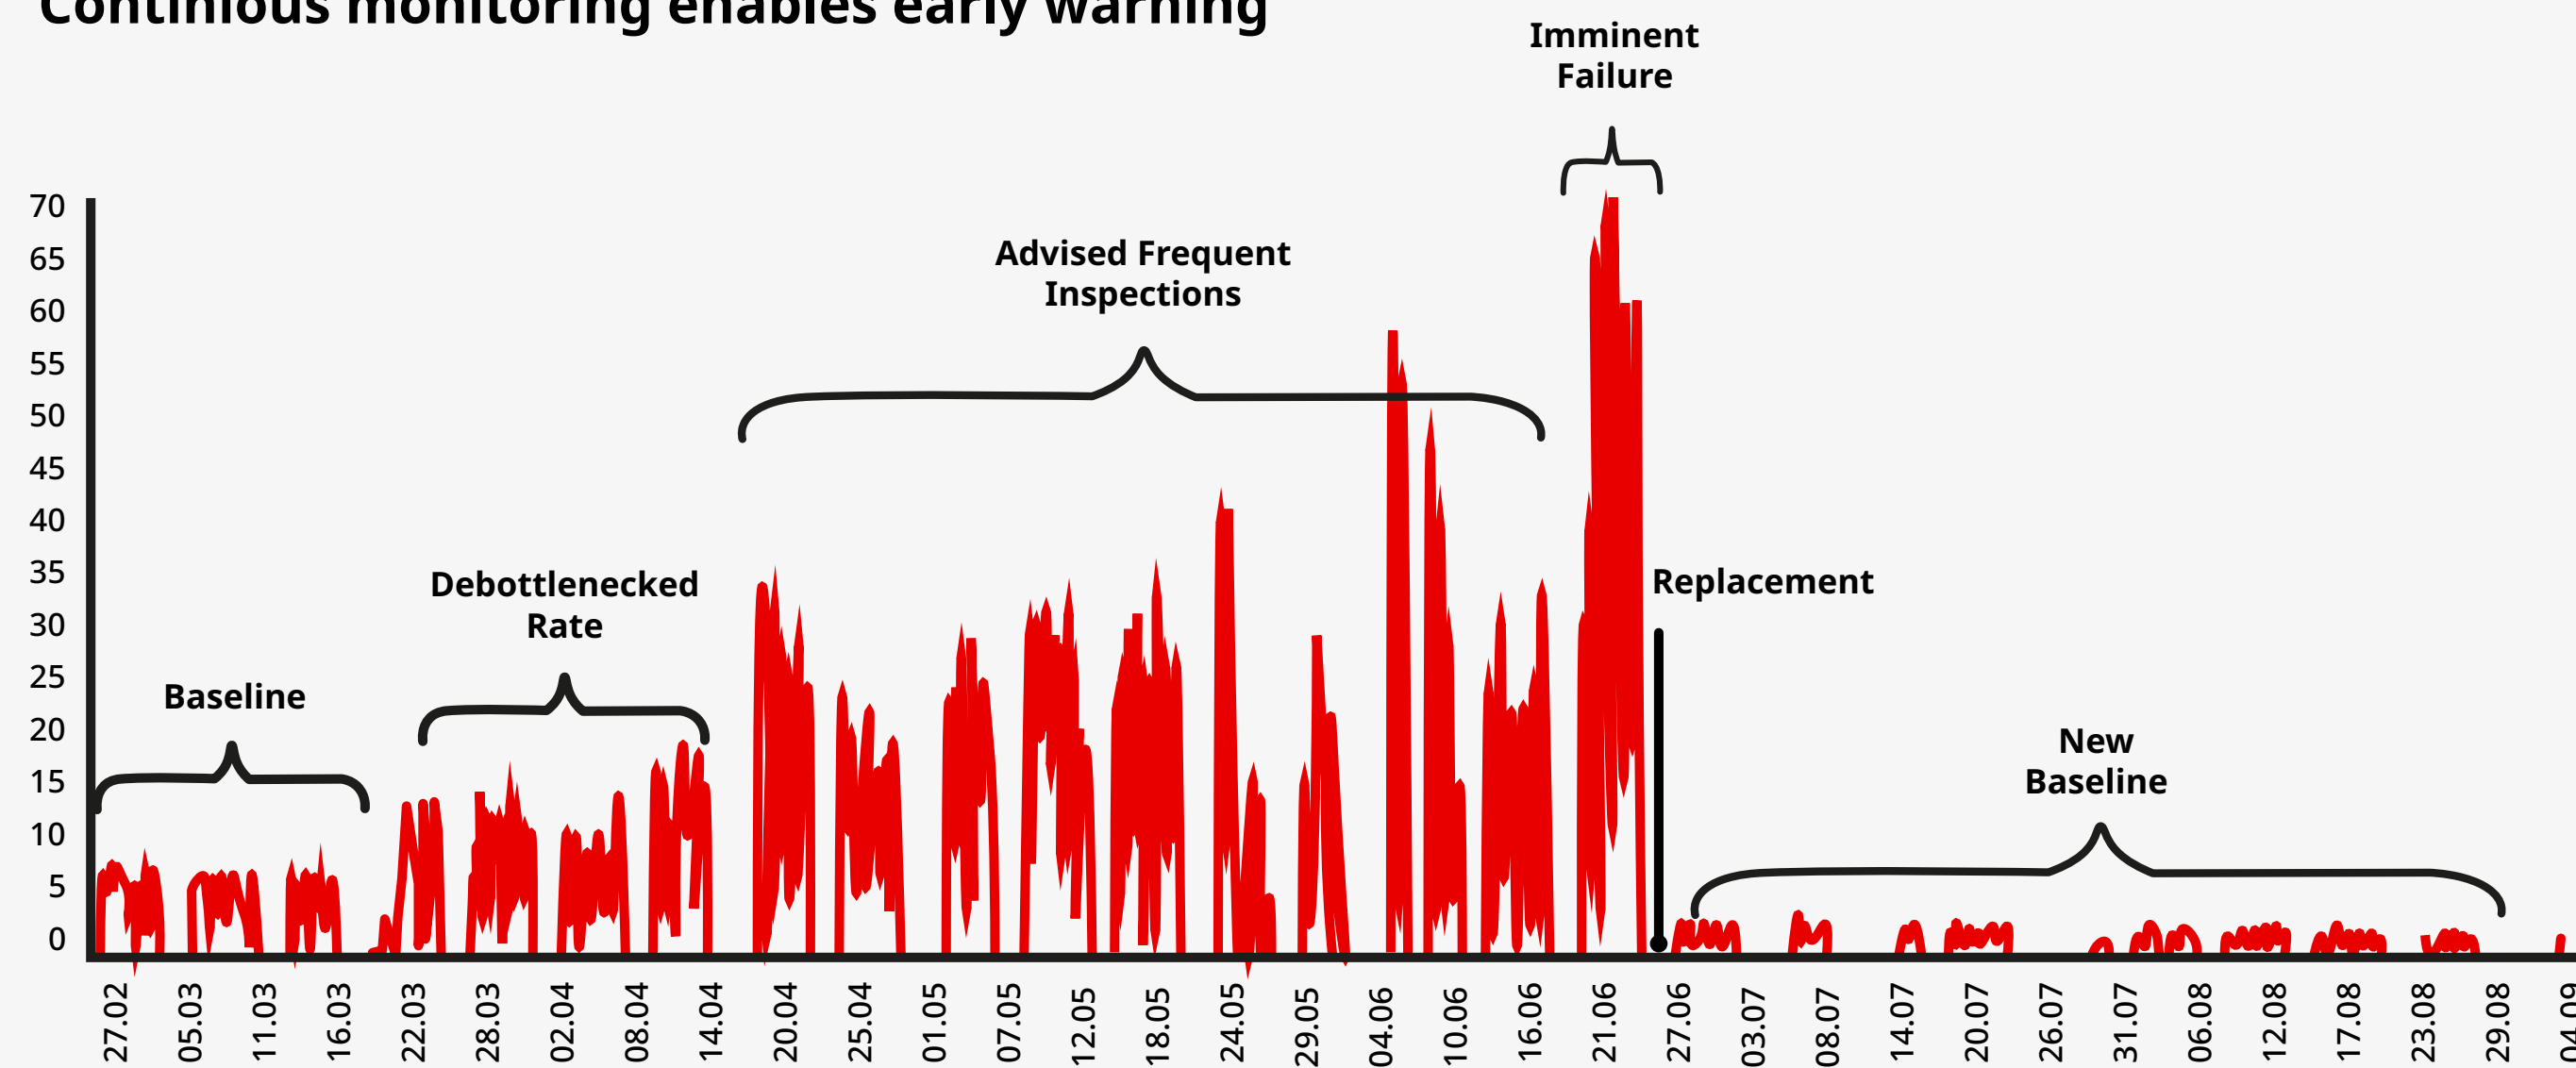
### Continuous monitoring enables early warning

RS Industria proved its worth within months when it highlighted a significant increase in overall vibration within a specific transfer box. With the increase flagged, the relevant spare components were procured as a precaution.

When vibration levels suddenly increased further a few weeks later, the team was alerted to the potentially imminent failure of the transfer box. The filler was stopped to replace the transfer box quickly and efficiently. Upon dismantling the old transfer box, the bearings were found to be collapsing, the sealed lubricant was contaminated with water and the unit was just hours away from a catastrophic failure – an event that would have caused the filler to be shut down for a minimum of two days.

Following the replacement of the transfer gearbox and the refitting of the vibration sensor, the new monitoring data showed that the filler was now operating within normal limits.
